**CORROSION RELATED FAILURES IN THE
PULP AND PAPER INDUSTRY**

Project 3309

**Report One
A Progress Report
to**

November 15, 1976

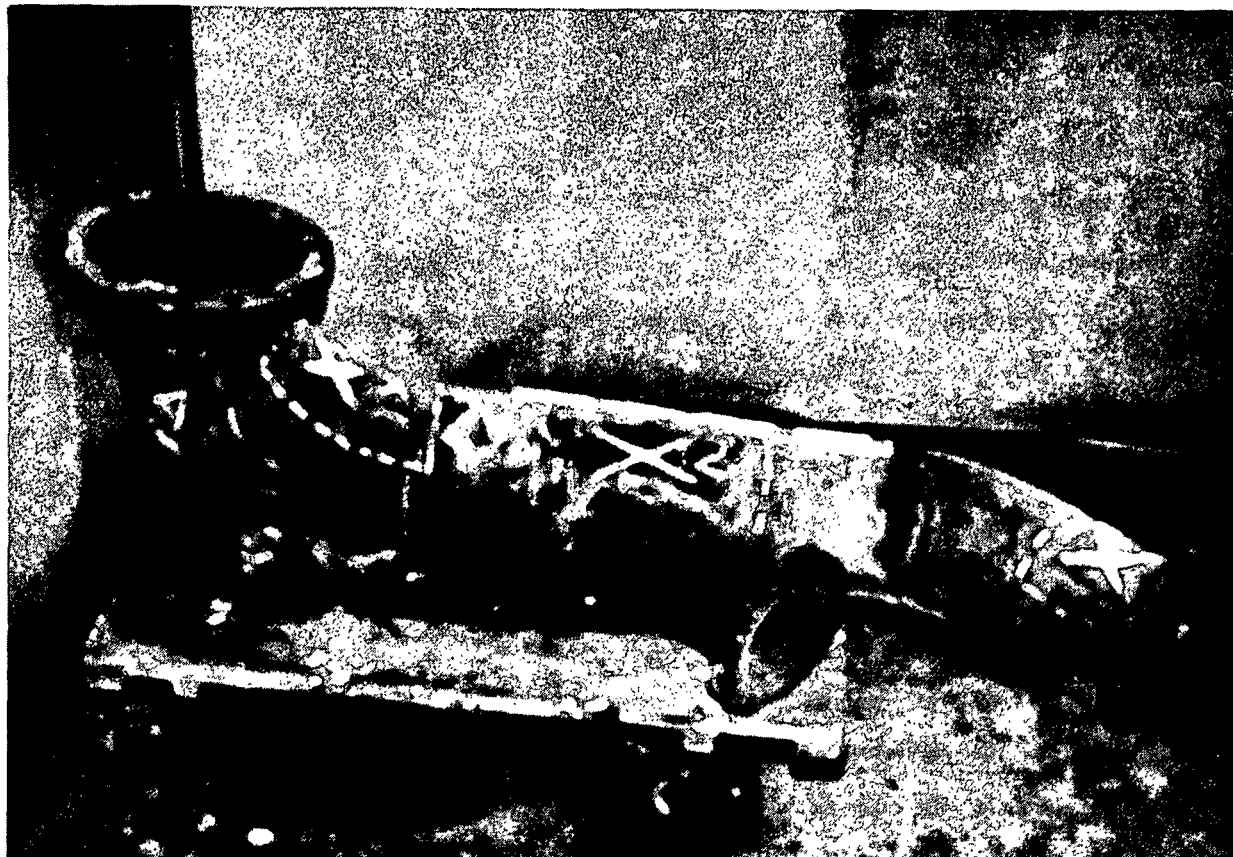
The white liquor line operated only 3 months before leaks developed in the catch basin adjacent to the pump station. The photograph in Fig. 3 shows three locations marked by an "X," where failure occurred. It is seen that each location is on the top side of the pipe and just behind or adjacent to the points where various sections were welded in the main body. In addition, there is a spot marked A (left side of the photograph) adjacent to the flush line pipe. No failure occurred at this point. Each of these sections was cut from the main body for further investigation.

Figure 3. Photograph of Failed Section Showing the Relative Position of the Pipe in Service and its Overall Size. The X Marks Indicate the Location of Failure While the A Mark is a Location of Special Interest

1. Insofar as possible a change in pipe material from mild steel to Type 316L stainless steel is recommended. The protective surface film on the 316L alloy is stronger and it resists erosion, cavitation, and oxidation much better than mild steel for this application. Greater weld integrity is made possible by

the low carbon content in this alloy. This will help prevent sensitization, intergranular corrosion and weld zone attack. All junctions between mild steel and stainless steel construction must be insulated to eliminate the galvanic effects in the old system.

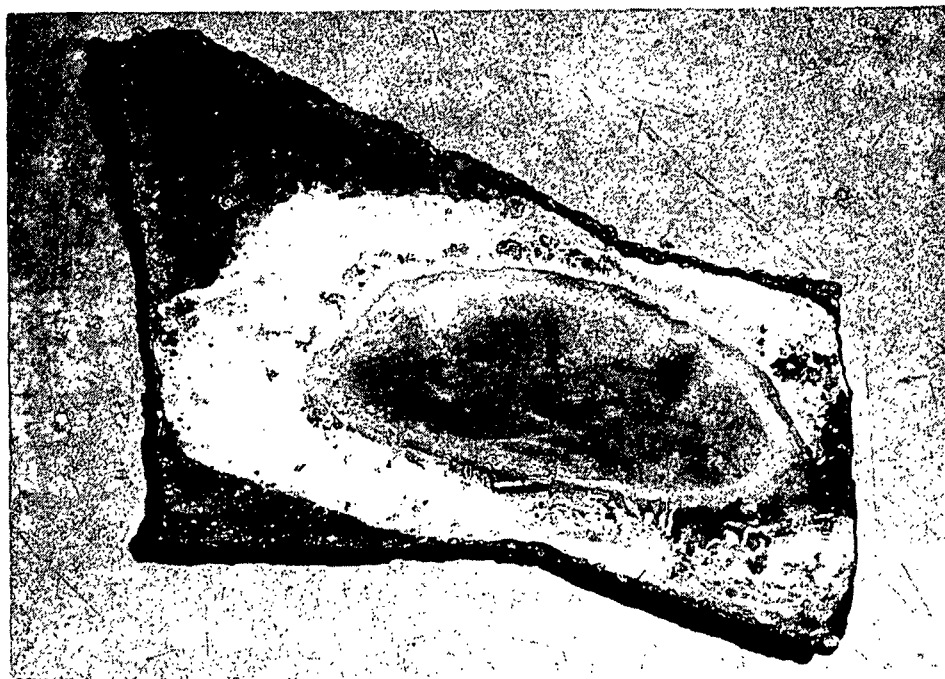
The photograph in Fig. 4 shows the inside of the pipe at location A. This picture is a typical appearance of erosion-corrosion. Note the "hills and valleys" and grooving that occurred in the center of this section. The entire spot (surrounded in white) is quite smooth and the grooves inside it are easily detected by feel. Although the pipe did not fail in this region, it would have done so with longer service times. The location of this attack is where erosion would be expected, i.e., near the bottom of the bend, but it undoubtedly was intensified by the flush line installation. The flush line extended beyond the inside diameter of the main pipe and aided the erosion in that area by creating additional turbulence.

Figure 4. Photograph of Section Marked A in Figure 3. It Shows an Area of Erosion-Corrosion as Outlined by the White Lime Deposit

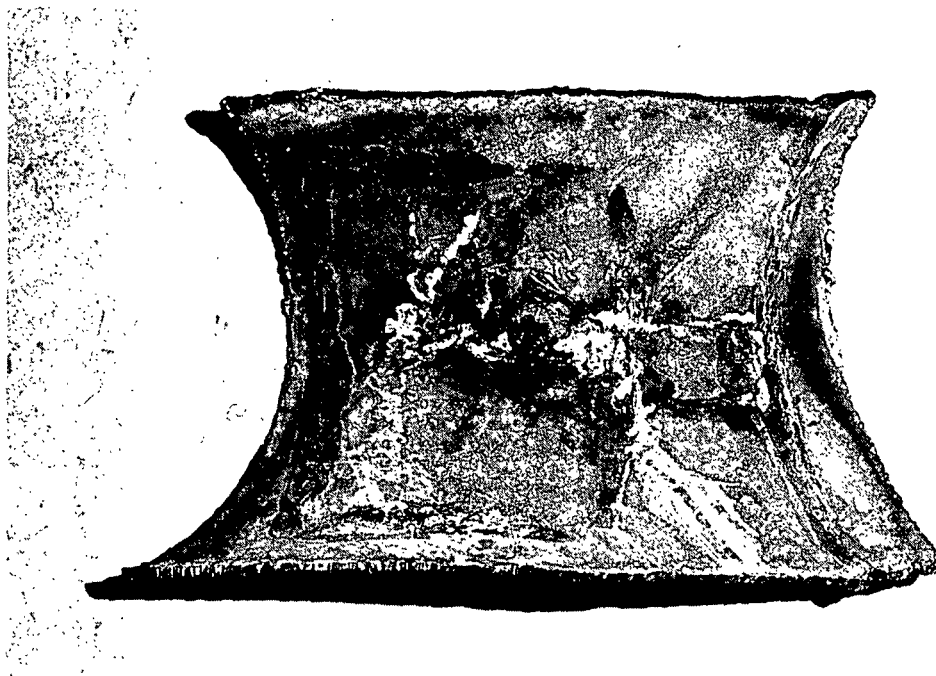
The photograph in Fig. 5 shows the inside surface of the pipe section cut from the top of the bend just below the 10-inch flanged end (left side of photo in Fig. 3). The large hole and remnants of the original metal seen to the right and center of the photograph demonstrates an area of extreme concentrated attack.

Figure 5. Photograph of the Pipe's Inside Surface at the Point of Failure Located at the Top of the Bend (Left Side of Figure 3).

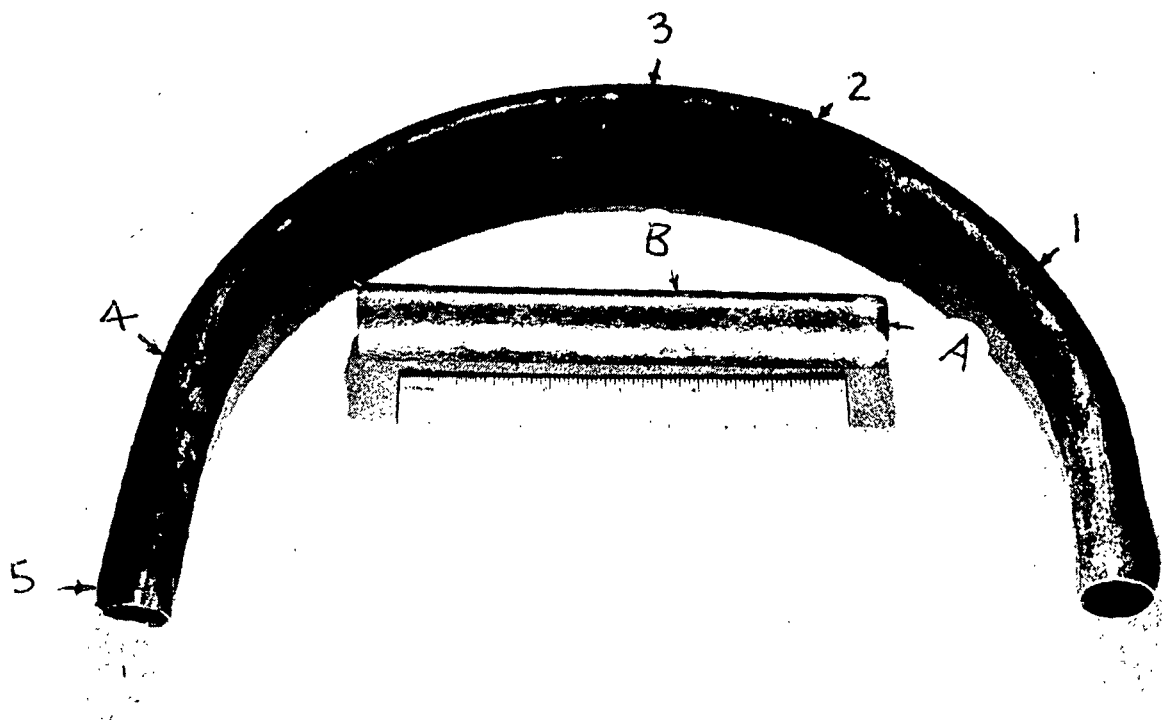
large corrosion pits and stress corrosion cracks while 2 and 3 show tears and cracks between pits distributed more toward the outside of the bend. Random pitting and crevice attack are present in Location 5 and 6. The straight section contains stress corrosion cracks at A and random pitting at B. All of these locations were examined more closely by sectioning the tubes at appropriate points.

Figure 8. As Received Samples of Wash Liquor Heater Tube. Locations of Severe Corrosion Attack are Indicated by Numbers on the U-bend Section and Letters on the Straight Section

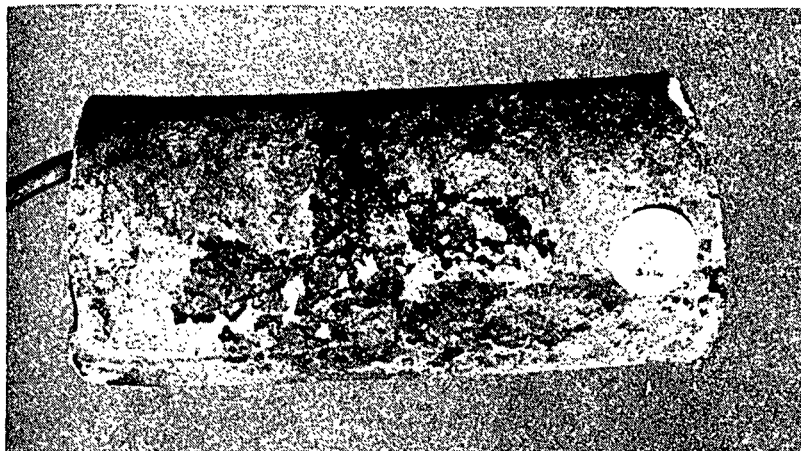
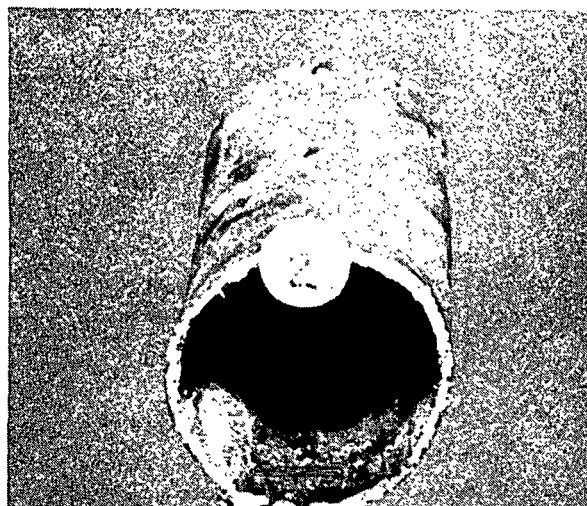
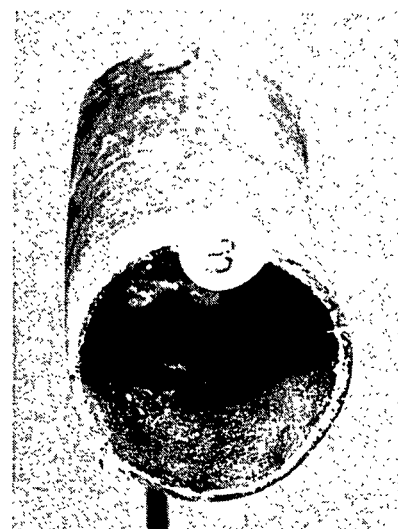
Pitting appears both on the outside and inside surfaces of the U-bend section but it is not as severe (as deep) on the outside surfaces — mainly associated with areas of heavy black stain. The more severe pitting on the inside

of the tube is beneath fibrous-scale deposits. In both cases the frequency of pitting is greatest on the outside of the bend. Figure 9 shows Locations 2 and 3 where this attack and fibrous deposits are clearly evident.

Figure 9. Top, Left - Pitting and Stress Corrosion Cracking Between Pits at Location 2 (Figure 8)
Top, Right - Fibrous Deposits Inside Tube at Location 2 (Figure 8)
Bottom, Left - Severe Pitting at Location 3 (Figure 8)
Bottom, Right - Fibrous Deposits Inside of Tube at Location 3 (Figure 8)

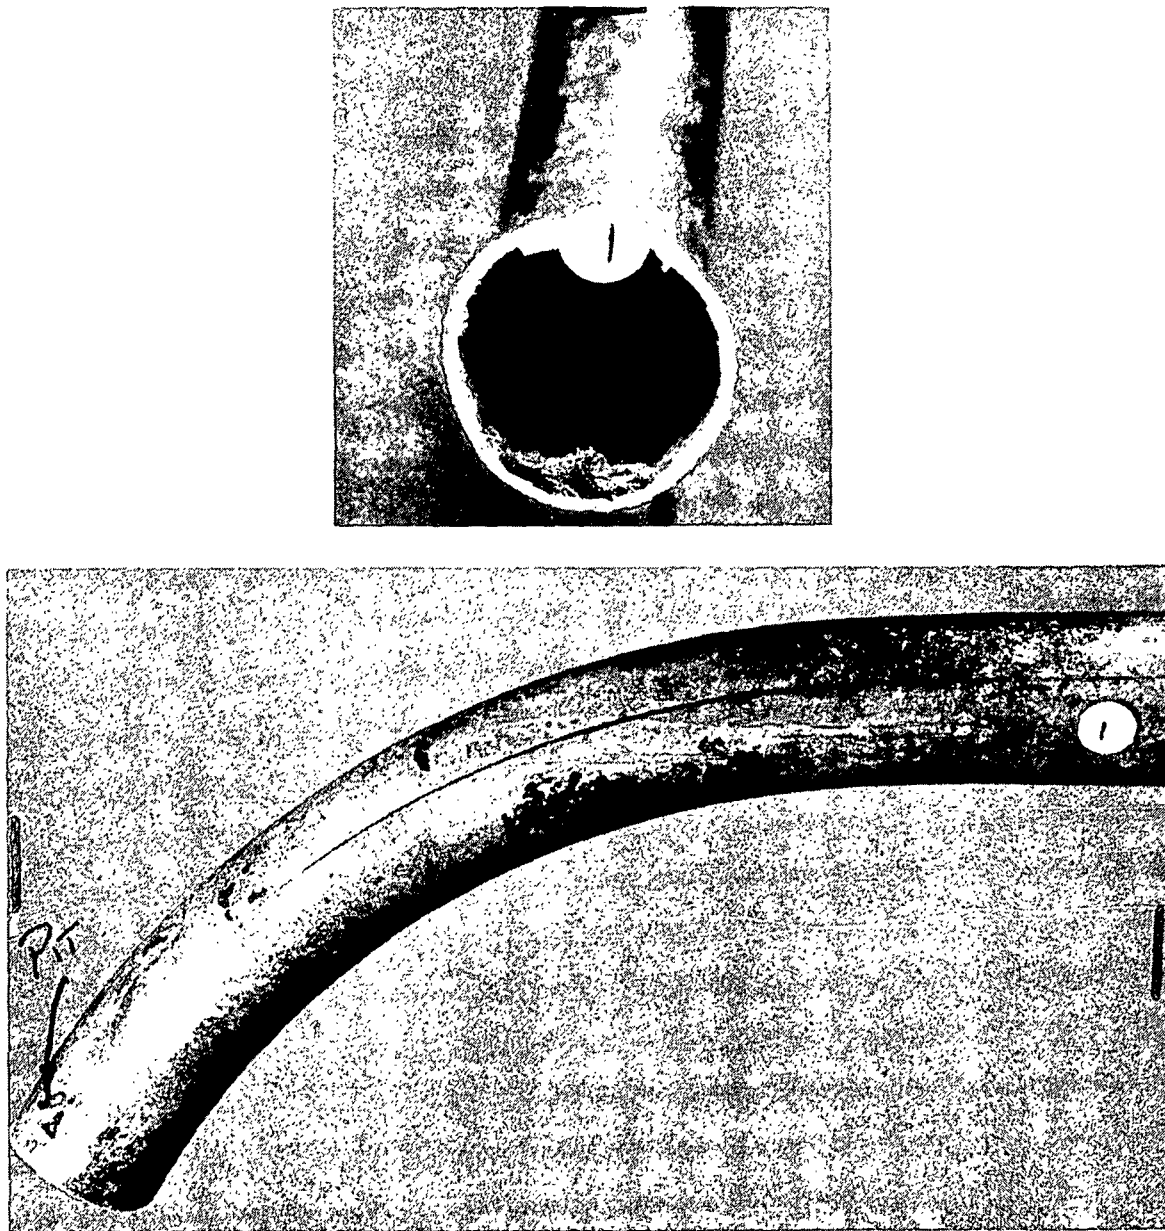
Stress corrosion cracking appears in a similar manner; i.e., frequency and severity is greatest on the outside of the bend where heavy fibrous deposits are present. Figure 10 shows this attack at Location 1. In this case the crack is seen emanating from a pit. Figure 11 shows another example of stress corrosion cracks and pitting in the straight tube section at Locations A and B.

Figure 10. Bottom - Stress Corrosion Crack Emanating from a Pit at Location 1 .
(Figure 8)
Top - Heavy Fibrous Deposit on Inside of Tube at Location 1 (Pit End).

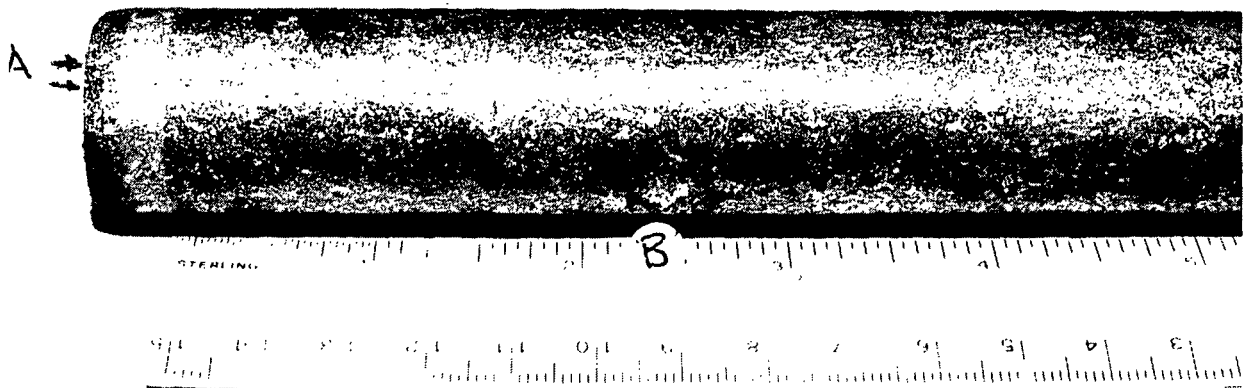
Figure 11. Close-up Photograph of Stress Corrosion Cracking and Pitting at Locations A and B, Respectively, in the Straight Section of Tube (Figure 8)

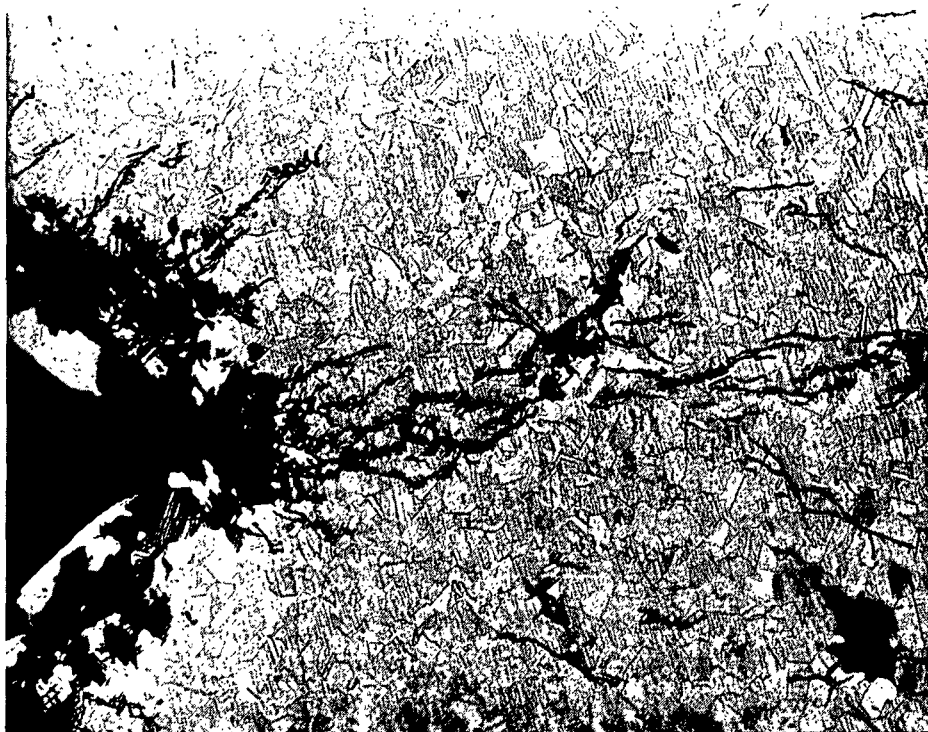
Figure 12. Transgranular and Branching Stress Corrosion Cracking
Emanating from the Pit (Left Side of Photograph) at
Location 1 (Figure 8)

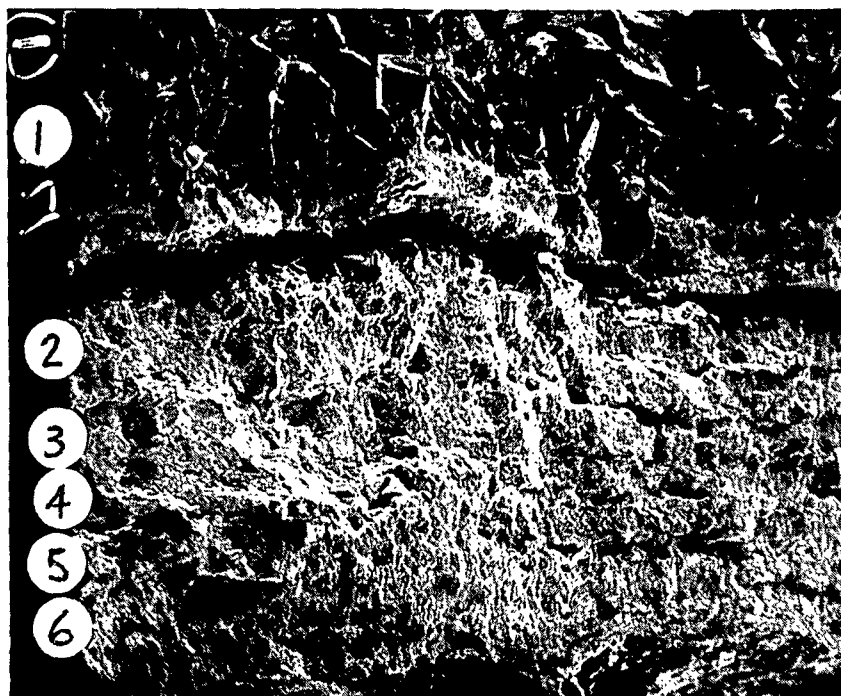
Figure 17. Cross Section of Corrosion Product Removed from South Wall of Precipitator A. The Six Layers were Analyzed for Composition and Structure

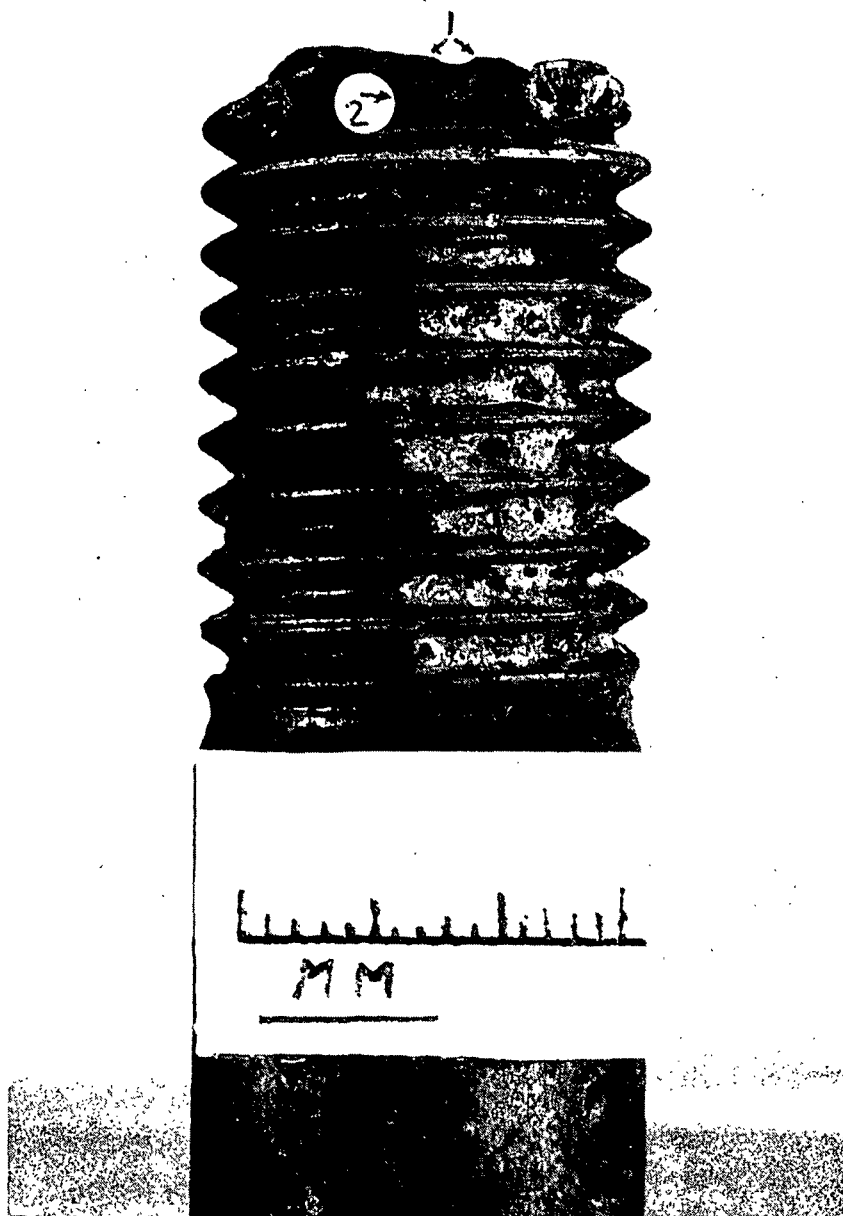
Figure 23. Photograph of the Fastening Bolt Which Failed in the Rapper Hammer Assembly in the Electrostatic Precipitator. Note the Heavily Encrusted Threads and Two Regions of Fracture Morphology. Region 1 Extends Over the Major Portion of the Fracture and it is Covered With Fatigue Striations. Region 2 is the Final Ductile Fracture Area

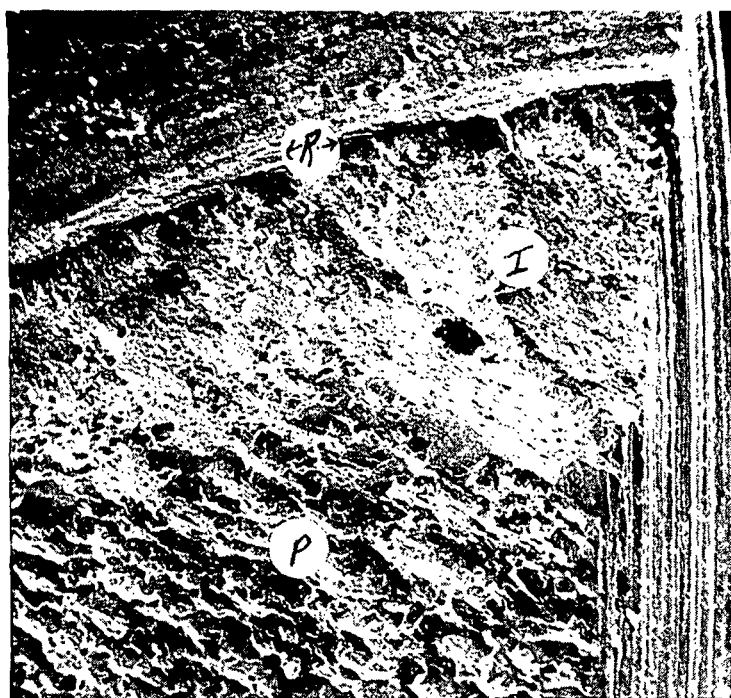
Figure 26. SEM Photomicrograph Showing a Region of Fatigue Crack Initiation (Labeled I) at the Thread Root (Labeled R) and the Crack Propagation Area (Labeled P)

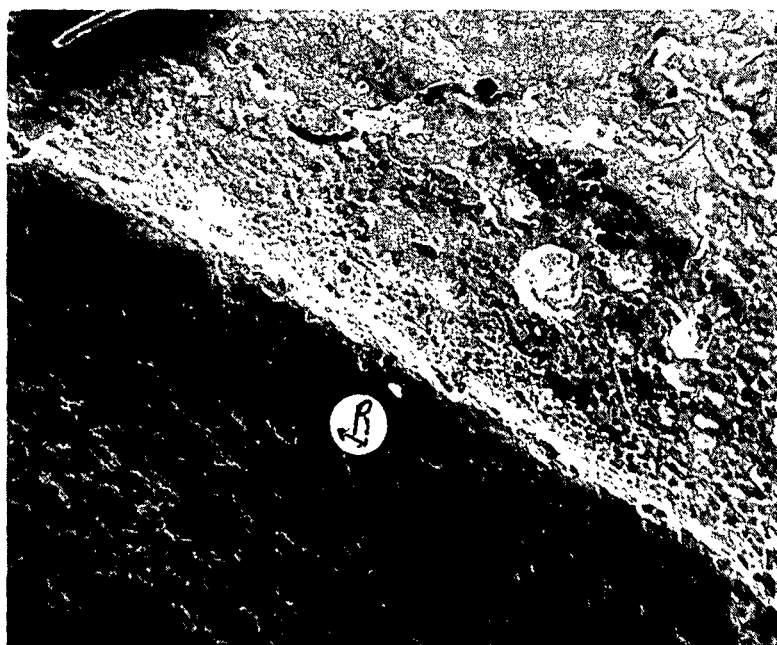
Figure 27. Close-up View by SEM Microphotography Showing Pitting and Crevice Corrosion Attack Within the Thread Root Area (Labeled R)

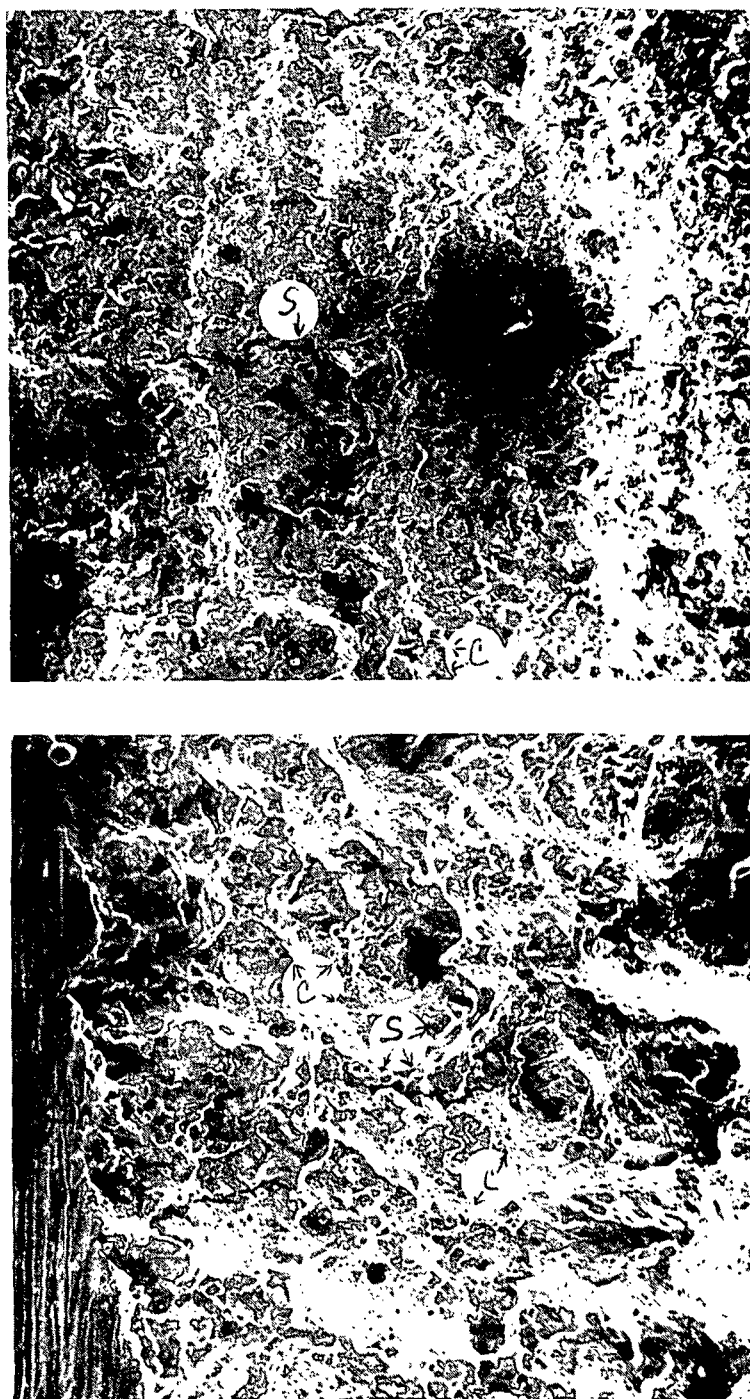
propagation, Fig. 28 shows numerous secondary cracks and corrosion pits along the major crack front.

Figure 28. SEM Photomicrograph of the Region of Fatigue Crack Propagation. Upper Photograph at 100X and Lower Photograph at 200X. Secondary Cracks (Labeled S) and Corrosion Pits (Labeled C) are Seen Throughout These Striated Regions

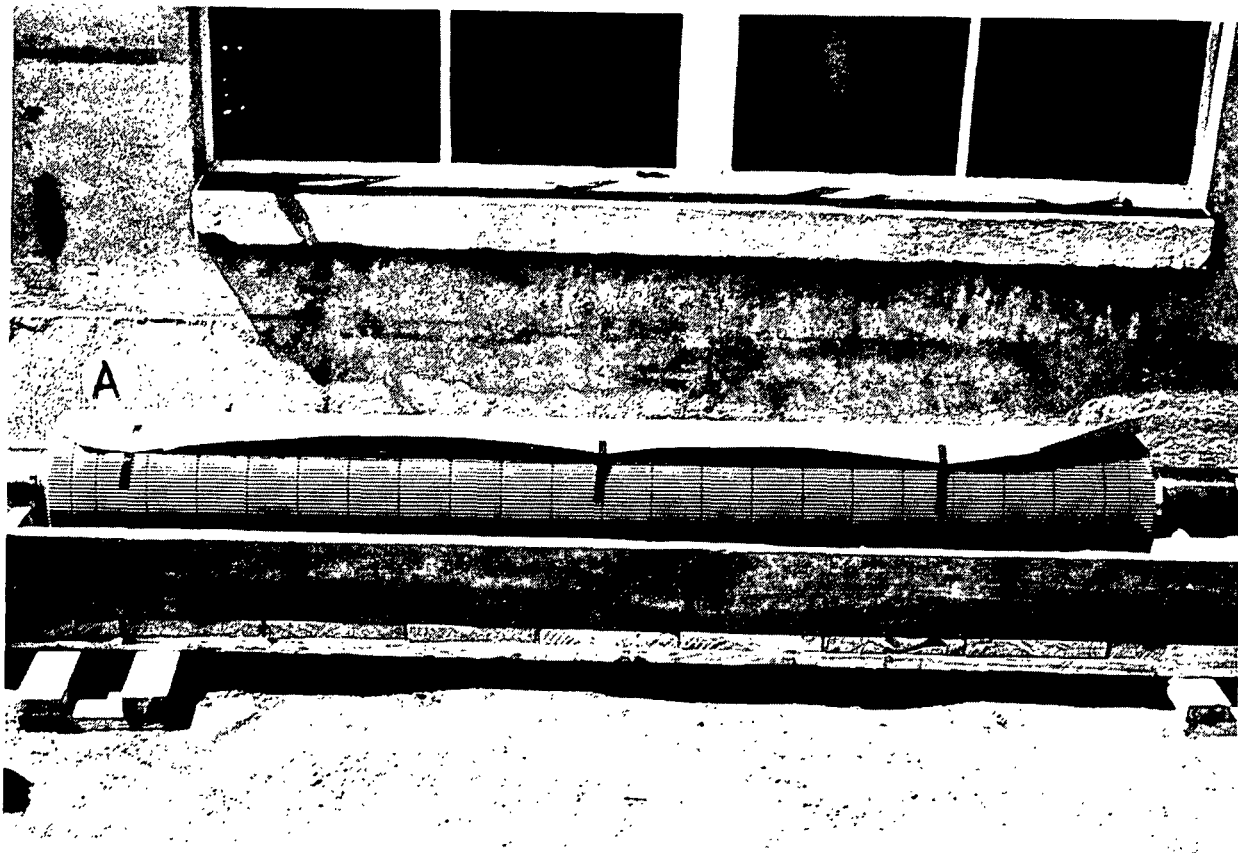
chrome plate. The valley of the flute profile was worn free of chrome plate and discolored from base metal corrosion and deposits. The original machining lines were not evident in this area and isolated, randomly distributed pits were also detected. A thin but uniform covering of chrome plate was observed along the sides of the flute with randomly distributed pin holes or small punch marks penetrating this coating.

Figure 29. Photograph of Worn Upper Corrugating Roll as Received. The End Marked "A" was Cut From the Roll for Closer Inspection

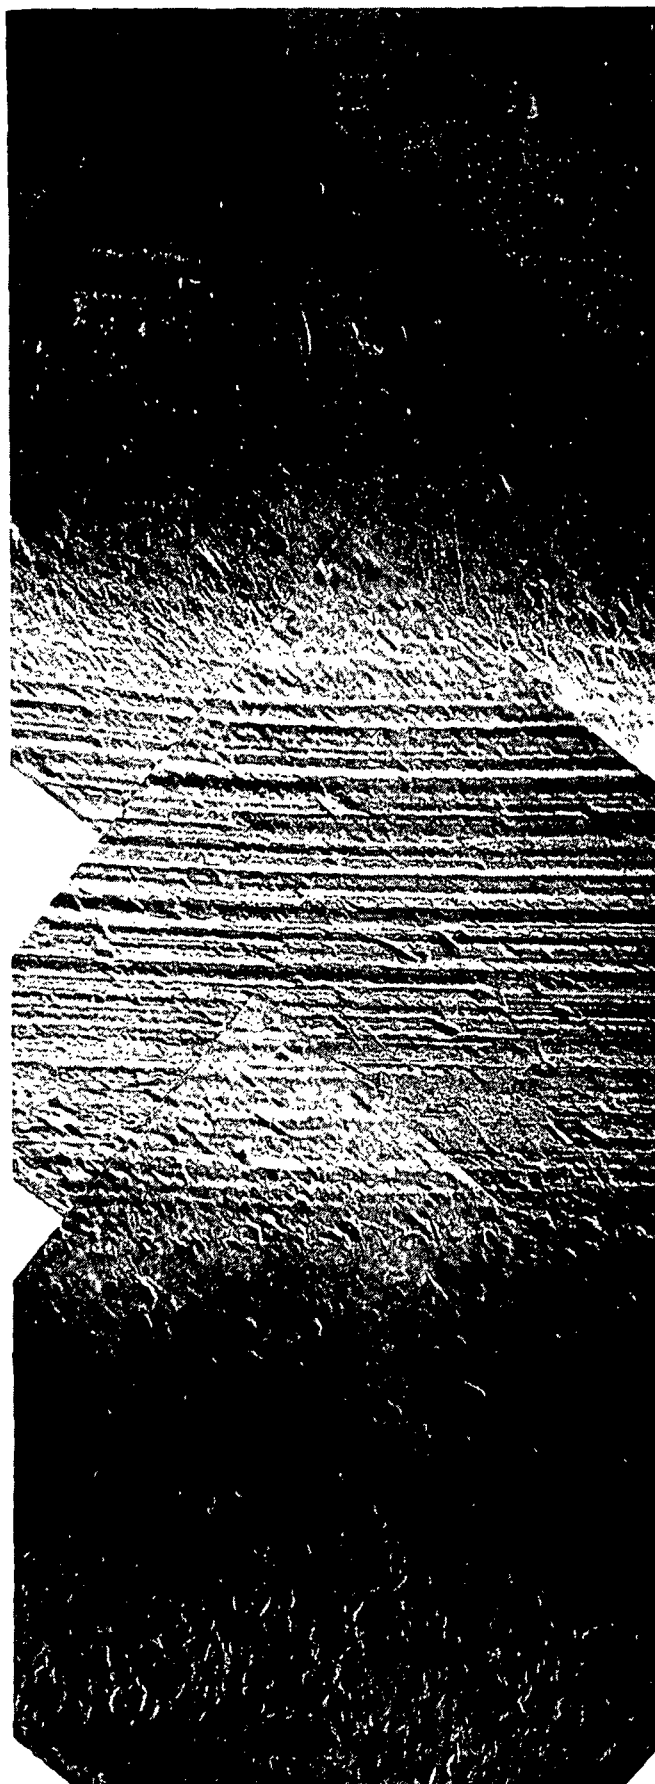
Figure 31. SEM Montage of Flute Profile in Sample 1 Showing the Surface Damage Sustained in Valley (Lower Left), Side (Center) and Tip (Top) of the Flute. Magnification 40X

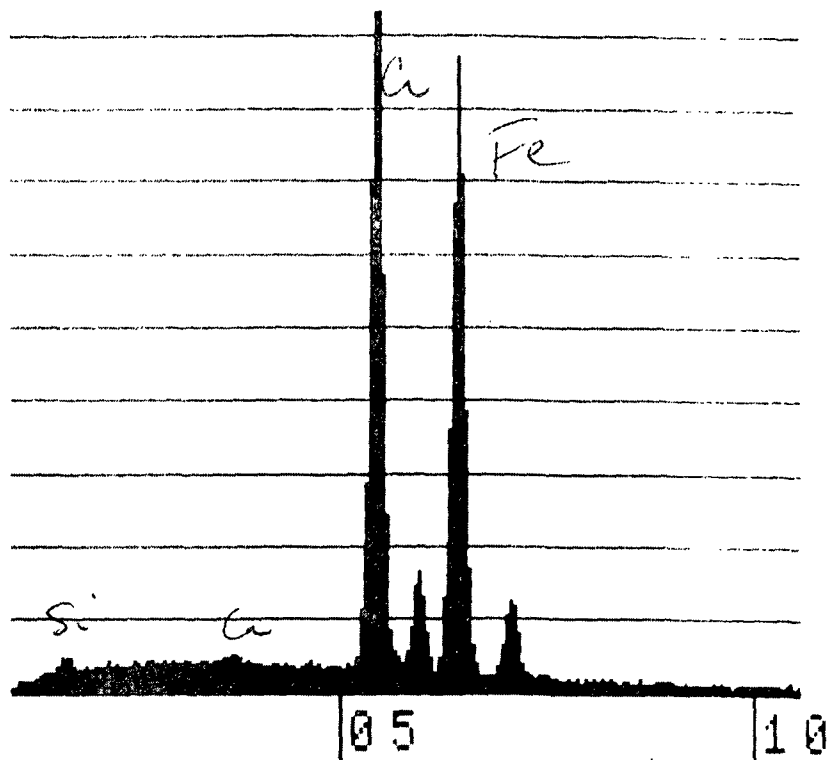
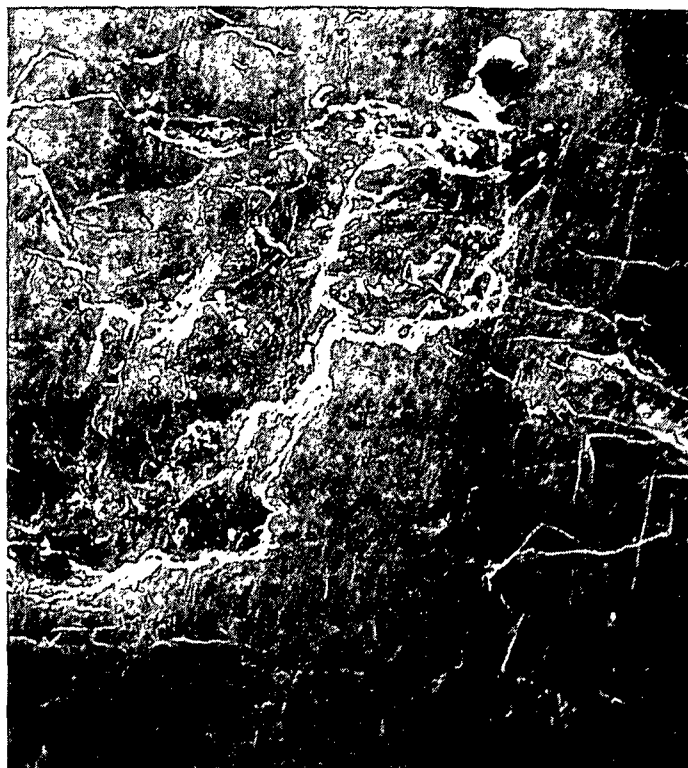
Figure 33. SEM Photograph (200X) and X-ray Spectra in a Local Region of Break-down in the Chrome Plate. Note the Multitude of Cracks (White Lines) Surrounding this Region

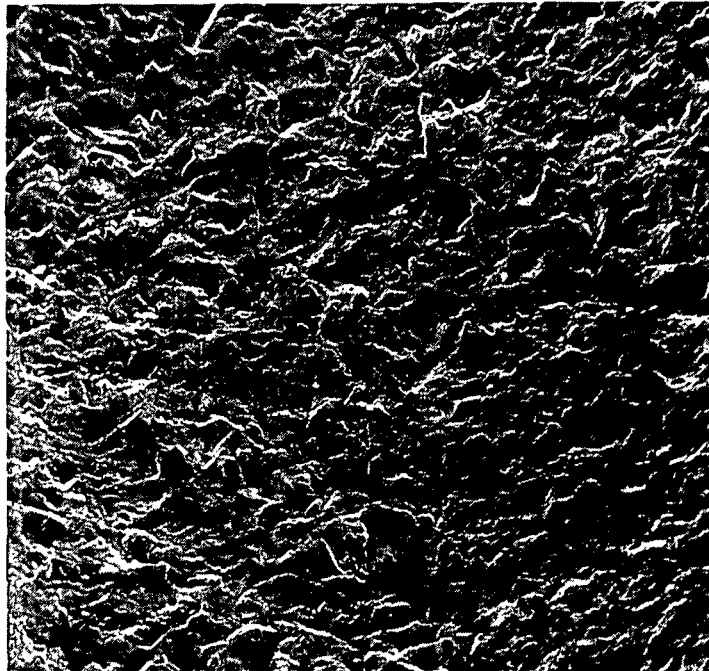
surface disruption was found in the valley and tip of the flute. The darkened pit noted visually in the flute valley of this sample turned out to be a circular discoloration under SEM examination (Fig. 34). Since this circular area is slightly depressed from the surroundings, it was probably not cleaned during sample preparation and thus appears dark. The photograph in Fig. 35 also shows that the extreme wear in the valley was in the form of "craters" (small areas of metal removal), and the sides and bottom of these craters were perforated with small holes. Figure 36 shows a close-up photograph of one of these craters. The x-ray spectrum of this region shows the base metal predominance (iron, chrome, nickel peaks) as well as the presence of silicon, calcium, phosphorus and sulfur. The calcium and silicon probably originate from the environment; e.g., corrugating medium, water, oil, while phosphorus and sulfur may be from the inclusions in the base metal.

Figure 34. SEM Photograph (100X) of the Round Dark Area in the Flute Valley of Sample 1 Which Appeared to be a Pit Visually. This Photograph Shows it to be a Circular Discoloration Without Change in Surface Morphology from That of the Surrounding Area

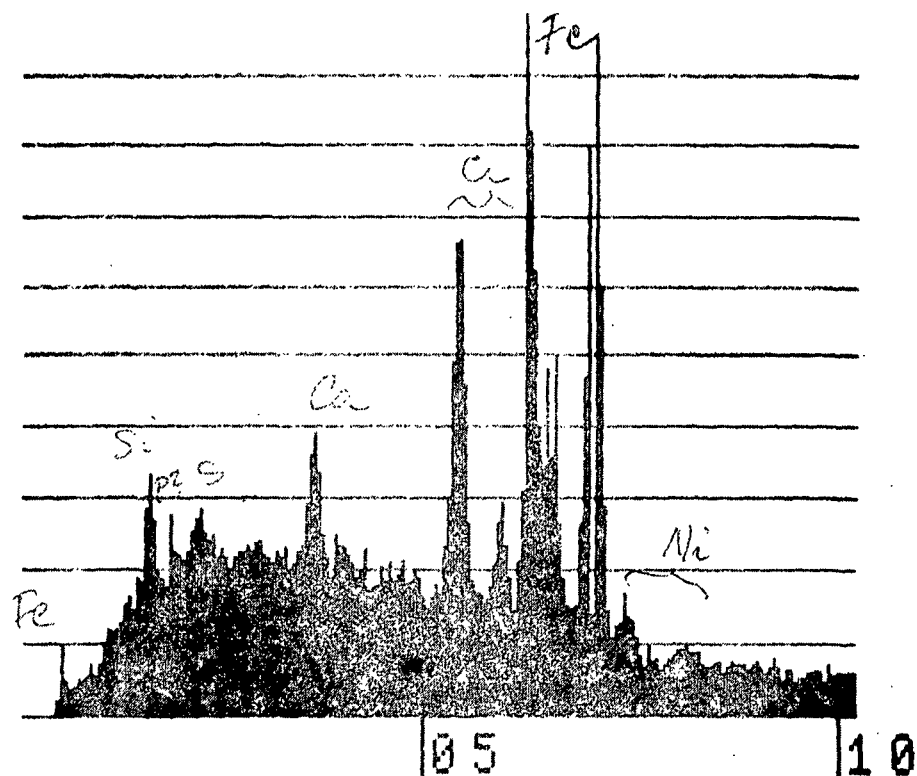
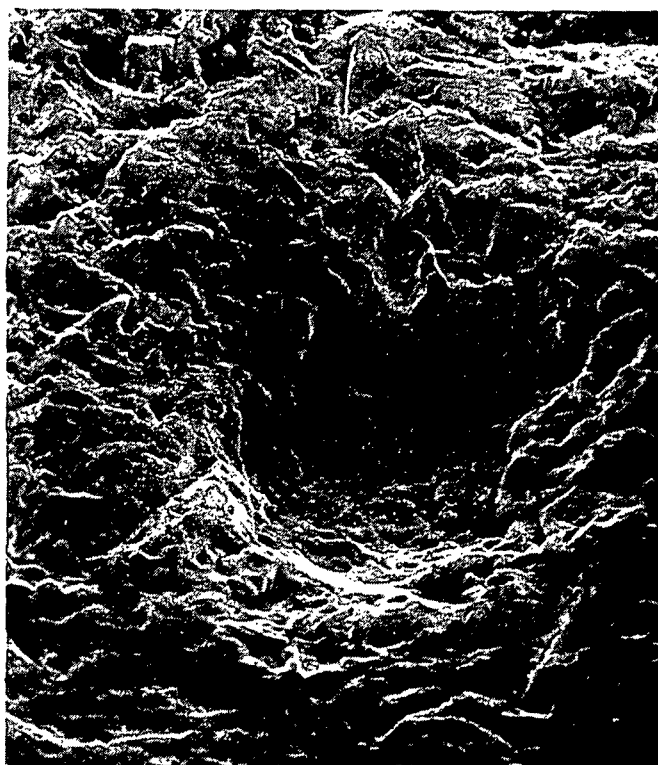
Figure 35. SEM Photograph (200X) and X-ray Spectra of the "Craterlike Surface Morphology Found in the Flute Valley of Sample 1

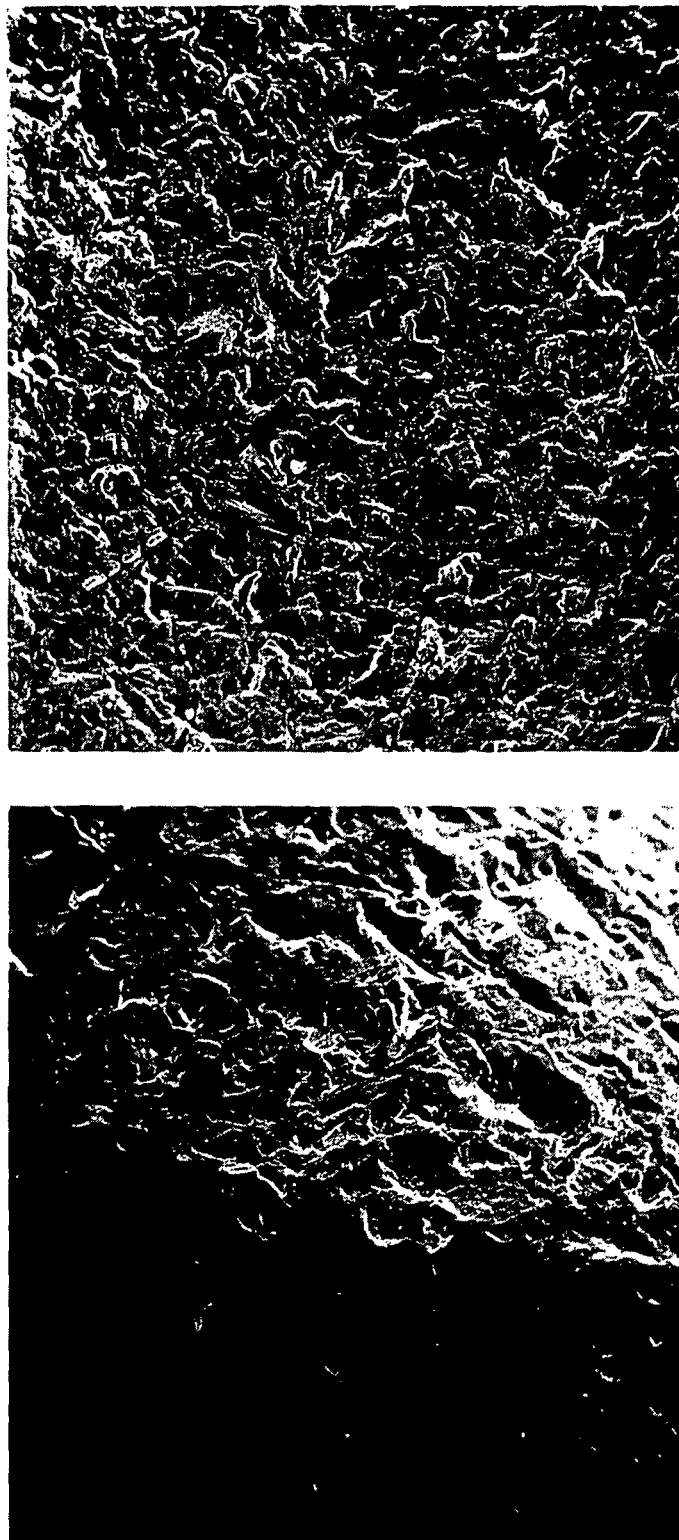
Figure 36. SEM Photographs (100X) of the Valley (Top) and Tip (Bottom) Surfaces of the Flute on Sample 3. The Perforated Craterlike Metal Removal on These Surfaces is Similar to That Found on Sample 2
